# SAMPLE ROOF SURVEY & INSPECTION

## NORTHLINE COMMERCE CENTER, BUILDING 4

**SAMPLE-2026-004**    Survey date October 14, 2026    19,200 SF white TPO    6 cores

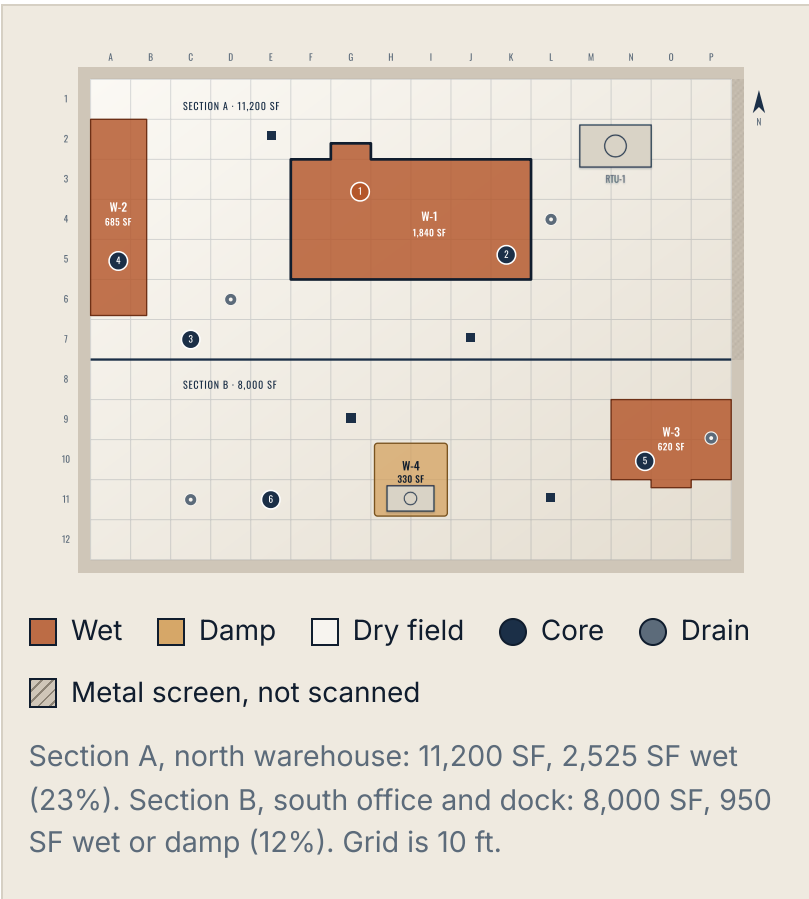
**18% WET**  
— 3,475 OF 19,200 SF

The wet insulation is in four defined areas. The inspection found local defects — an open seam, pulled flashing, a weeping drain, punctures, and closed blisters — and the dry field membrane is still sound. The deck can stay, so the wet areas come

out, those details get repaired, and the whole field is coated.

This roof is 18% wet, in four areas. Section A is 23% wet only because W-1 and W-2 sit there. The other 8,675 SF of Section A read dry, and core C-3 agrees. That is why the call is Repair + Coat, not Recover. The guide is how this demo was called. It is not a code section.

Also on the plan: RTU-1, dry, grid M2. RTU-2 inside W-4. Drains D-1 at L4, D-2 at D6, and D-4 at C11 are dry. D-3 at O10 is inside W-3. Four small squares are vents and one exhaust, all in the dry field. The hatched east wall of Section A is a metal equipment screen, inspected visually and left out of the scan and out of the square footage. Inspection findings F-1 through F-10 use this same grid.

Repair 3,475 SF and coat the field. The contractor prices it from the schedule and the cores.
